# CLUSTERS OF CYCLONES AND THEIR EFFECT ON COAST ABRASION IN KALININGRAD REGION

**Abstract:** The shores of the Kaliningrad Region (the Russian part of the South-Eastern Baltic Sea) are regularly exposed to extreme storms, which leads to intensive abrasion and flooding of the land. Based on archival data, meteorological monitoring, forecast and synoptic maps, an analysis of extreme storms observed in the autumn–winter periods of the early 21st century was done. The cyclone type was determined using the HYSPLIT (Hybrid Single Particle Lagrangian Integrated Trajectory Model), which makes it possible to reconstruct the trajectory of the approach of the atmospheric vortex to the coast. The seasons with clusters of storms were identified, when deep cyclones affected the coasts of the Kaliningrad Region in a relatively short time. Regardless of the type of trajectory, storms cause destruction of both natural and infrastructure objects. But the shores of the northern exposure are most susceptible to destruction by “diving” cyclones, the wave regime of which has a high potential energy. Earlier it was noted that the frequency of cyclones with northerly winds increases. Clusters of norther

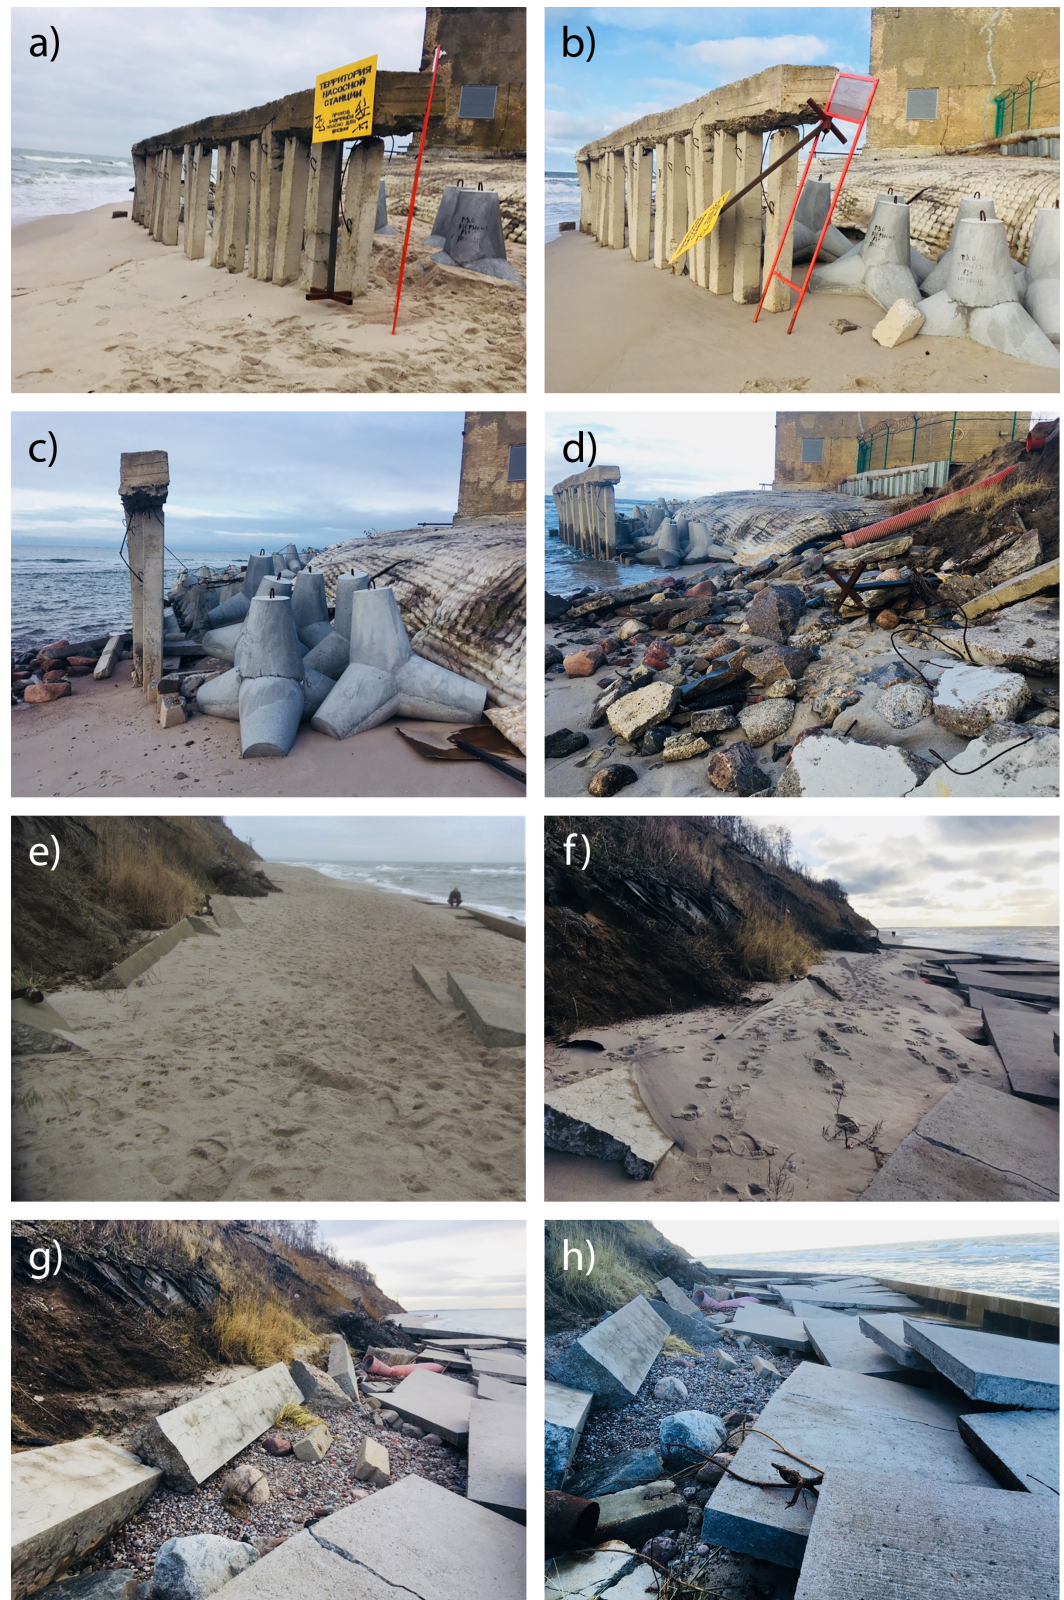
**Figure 3.** Dynamics of the destruction of engineering structures and the slope in the village Yantarny: (a–d) at the pumping station; (e–h) – near the bank-protective retaining wall: (a) and (e) – January 4, 2022; (b) and (f) – January 18, 2022; (c) and (g) on January 23, 2022; (d) and (h) on February 11, 2022.

- in the village Pokrovskoye was broken and the slipway for boats collapsed;
- in the southern part of Yantarny, sections of the retaining wall were washed away and collapsed, and on both sides of it, the cliff bank was partially collapsed; in the protective coastal structure near the pumping station of the amber plant, the geotextile cementing shells (slabs) of BetoBOX, the girdle and the newly erected structure of shaped blocks (tetrapods) were displaced and deformed (Figure 3). In the northern part of Yantarny, in the area of the Blue Flag beach, infrastructure facilities, non-stationary buildings, and wooden flooring were damaged or completely destroyed;

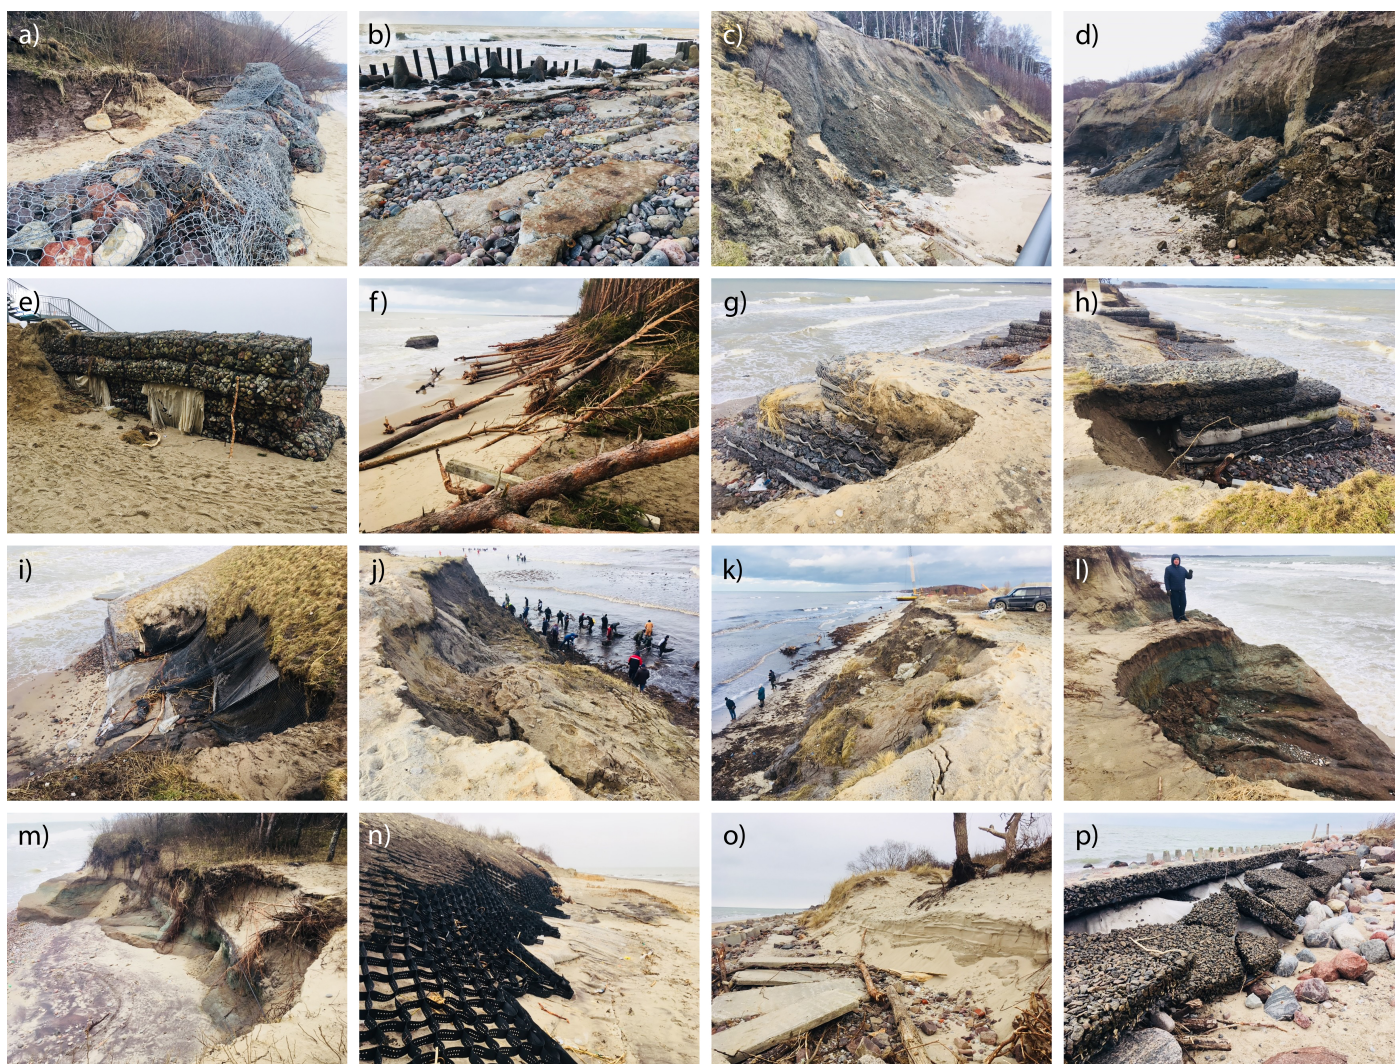
**Figure 4.** Erosion of the shores of the northern coast of the Sambia Peninsula: (a) Svetlogorsk city on February 15, 2022; (b) Svetlogorsk city on January 31, 2022; (c) Pionersky city on February 25, 2022; (d) village Zaostrovye February 12, 2022, (e) village Zaostrovye February 7, 2022, (g) Kulikovo February 1, 2022, (h–k) village Roshchino February 1, 2022, (l–m) village Sokolniki May 2, 2022, (n) the western beach of Zelenogradsk February 2, 2022, (o–p) the root of the Curonian Spit September 3, 2022.

- from Cape Taran, the entire northern coast of the Sambia Peninsula was marked by sea erosion of coastal cliffs, erosion of the native coast with landslides and tree collapse (Figure 4);

- in the area of the village Otradnoye, active erosion of the coastal cliff was accompanied by the collapse of extended sections of the piled concrete belt. In the city of Svetlogorsk, in the western part of the beach, along a stretch of several tens of meters, gabion structures (built as supports for crumbling cliffs) collapsed along with slope erosion and landslides (Figure 4a). In the cities of Svetlogorsk and Pionersky, promenades were damaged (staircases, sections of fences and handrails, embankment coverings, retaining walls made of gabions, a technical road made of concrete slabs) (Figure 4b, c);

- in the section from Pionersky to Cape Gvardeisky, the slope receded by 1–4 m with the destruction of part of the pine forest (Figure 4d). In the village Zaostrovye the gabion retaining wall at the base of the slope (built in 2016) did not save the cliff behind it from collapse (which had already been partially damaged during the *Alfrida* storm in 2019). The slope receded from the base of the gabion by more than 8–10 m, completely exposing the side and rear parts (by 6–8 m) of the already moving and

- lopsided protective structure (Figure 4e). At the stairway above the gabion, the *Ida* storm swept away several lower flights of stairs and twisted the concrete base;

- in the village Kulikovo, in the back part of the constructed bank-protective piled concrete belt with stone boulder fill (construction in 2020), the formed slope subsided with the exposure of the geotextile substrate. At the new slipway for boats, the soil was washed away and the boulder riprap was destroyed. A significant part of the pine forest was destroyed with the collapse of dozens of trees onto the beach; in some places the slope receded by 3–5 m. Inside the remaining narrow forest belt, there was a pile of uprooted and broken pines (Figure 4f);

- east of the village Kulikovo (village Roshchino) two coastal protection structures were damaged. On both sides of the bank-protective retaining wall made of gabions (in the design of 2018, box-shaped and mattress gabions), erosion of the slope was formed to a depth of more than 2–3 m, exposing the base, side and rear parts of the structure (Figure 4g, h). The second bank protection structure (~200 m east of the first structure), built in 2018, which has a complex multi-layer structure (geotextiles, geomats, geogrids, big bags, metal meshes, gabions), was severely destroyed along the line of contact with the collapsed slope, survived only gabion wall, behind which deep dips of 2–3 m were formed (Figure 4i). Buried concrete slabs with protruding metal rebar and heaps of woven Big Bags (or FIBC Big Bags) were exposed in front of this bank protection facility. Throughout the entire area, a system of cracks formed parallel to the cliff, followed by soil slippage and the formation of landslide ledges up to 2–4 m (Figure 4g–k);

- at the village Sokolniki, the toe of the slope washed away, followed by the collapse of the low cliff. Pointwise, the slope receded to 2–5 m (Figure 4l, m), the edge of the foredune was eroded, and a 1.5–2 m high erosion ledge was formed;

- in the western part of Zelenogradsk, the slopes of the foredune reinforced with geosynthetic materials were damaged (Figure 4n). The central part of the promenade, flights of stairs, the construction site of the cafe, as well as the wooden promenade and wooden slopes to the sea (opposite the city park) were damaged, the edge of the foredune was washed away with the formation of a washout ledge of more than 3 m (the edge of the foredune receded by 1–2 m), and a new slipway and infrastructure elements were damaged near the cemetery. There was a breakthrough of the foredune in the root part of the Curonian Spit, both the old bank protection structures and the newly built ones were damaged (with collapse in the rear part of the structures) (Figure 4o, p). In the village of Lesnoye on the Curonian Spit, the slope of the foredune receded by 2–5 m. The wooden promenade and coastal infrastructure facilities were damaged.

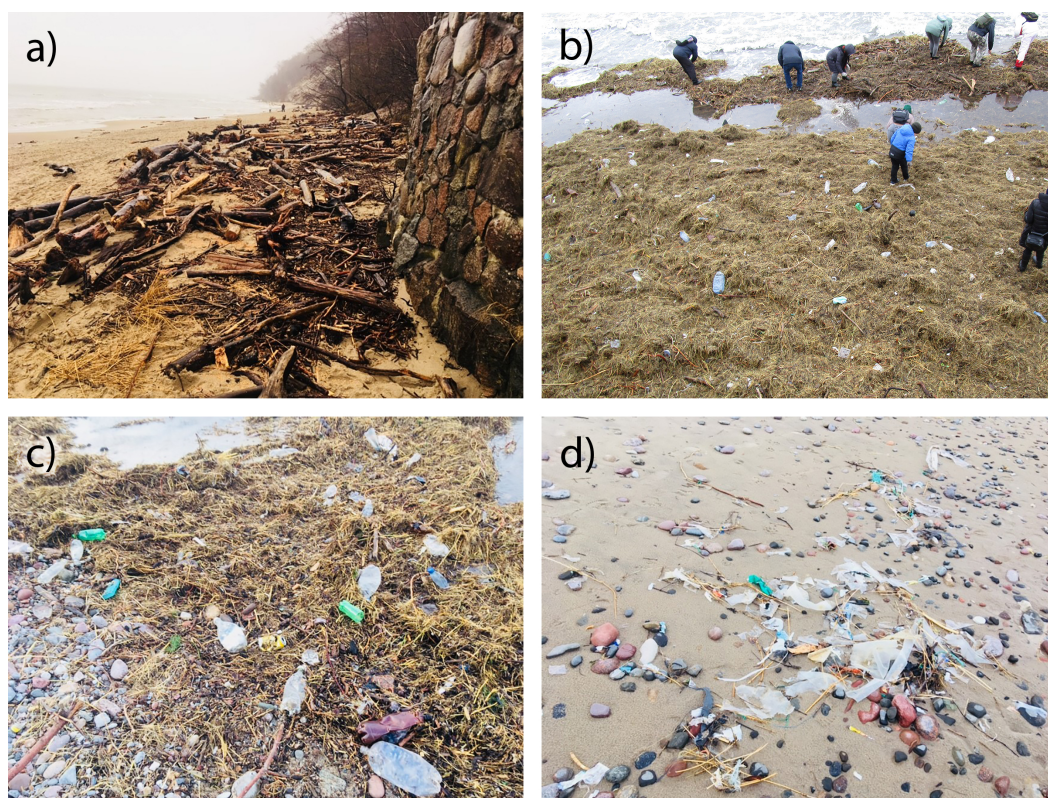
**Figure 5.** Storm discharges onto beaches containing plastic debris: (a) village Otradnoe January 27, 2022, (b) Zelenogradsk (city beach) February 2, 2022, (c, d) village Sokolniki May 5, 2022.

After the passage of *clusters* of strong storms in the autumn–winter period on the shores of the Kaliningrad Region, erosion of the bases of cliffs and foredunes is observed everywhere, followed by the strongest collapse of slopes, landslides, the formation of erosion ledges up to 2–3 m, slope retreat up to 1–5 m, damage or destruction of coastal protection structures and objects of coastal infrastructure. All deformed coastal protection structures turn out to be a source of emission and pollution of beaches with geosynthetic materials that were part of their structures (geocells, geomats, bags and big-bag containers, geotextiles, fragments of plastic-coated metal meshes from broken gabions, fragments of BetoBOX shells, waterproofing film, fragments technical interlayers made of expanded polystyrene, etc.) [Esiukova et al., 2018]. It should be noted that in the inter- and post-storm period, all the beaches were covered with a huge amount of grass from eroded slopes, branches and uprooted bushes, algae, wood chips and fragments of wooden piles, and tree trunks. But all these biological ingredients of post-storm erosion of slopes were mixed with mega-, macro-, meso-, micro-debris with a predominance of the anthropogenic component – plastic (Figure 5), which leads to new environmental problems [Chubarenko et al., 2022, 2018; Esiukova, 2017; Esiukova et al., 2018].
