ACTIVATION OF DANGEROUS NATURAL PROCESSES ON THE TERRITORY OF THE KABARDINO-BALKARIAN AND KARACHAY-CHERKESS REPUBLICS

Abstract: The paper considers the manifestations of dangerous natural processes and their consequences in the territories of two republics – the Kabardino-Balkarian and Karachay-Cherkess Republics for the period from 2015 to 2022. On the basis of the collected material, an analysis of the manifestations of hazardous natural processes was carried out and maps-schemes were compiled.

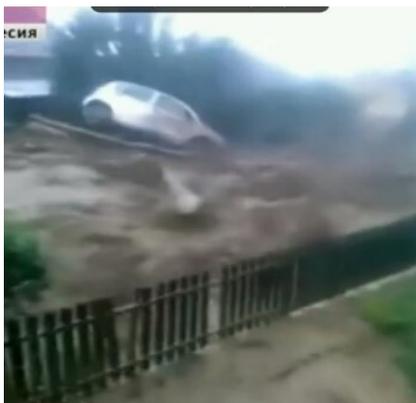
Figure 1. Consequences of mudflows in Zelenchuksky and Urupsky districts of the KChR on July 1, 2015 [Kyul et al., 2021b].

For example, on the territory of the Karachay-Cherkess Republic, on July 1, 2015, numerous mudflows occurred in the Zelenchuksky and Urupsky districts, caused by heavy rains. The elements dealt a powerful blow to settlements as well. Roads were washed out, household plots were flooded. One person died, two were injured (Figure 1) [Kyul et al., 2019a, 2021b].

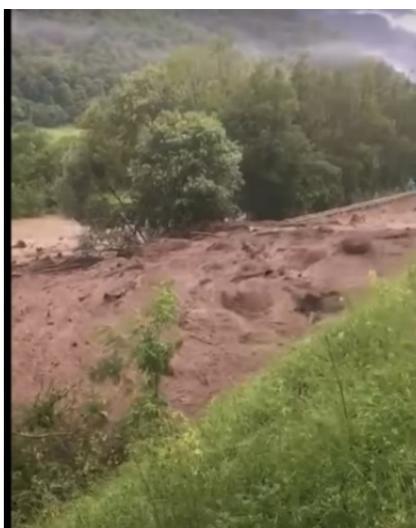
Figure 2. Mudflow descent along the left tributary of the Teberda River to the federal highway “Cherkessk-Dombai” on 06/16/2018 [Kyul et al., 2021b].

Mudflows descended in Urupsky, Zelenchuksky and Karachaevsky districts on June 16–17, 2018. In the village of Kurdzhinovno, 110 farmsteads were flooded, mud flows blocked the Karachaevsk-Uchkulan road. The dam on the Khusa River in the village of Zelenchukskaya and the approach to the pedestrian crossing over the Bezhgon River in the village of Storozhevaya are washed out. Mudflow descended in the village of Khasaut-Greek. More than 500 households, a school and a kindergarten were flooded in the village of Pregradnaya. The mudflow that came down between the villages of Upper Teberda and Lower Teberda blocked about 100 m of the road (Figure 2).

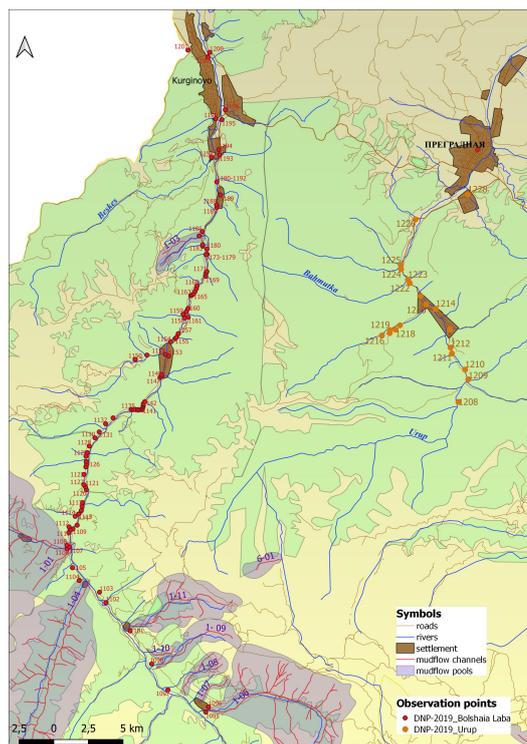
Figure 3. Map-scheme of the actual exposure to natural hazards of linear facilities in the Bolshaya Laba and Urup river basins (KCR).

Also, based on the results of field trips, schematic maps have been compiled, with GPS points applied (for example, Figure 3).

All the places where the road intersects with streams (waterways), drifts and erosion of the highway are recorded. The wooden bridge over the Zagedanka River is in disrepair – the bridge supports are clogged with karch, the banks are washed away. The floodplain forest is flooded. Traces of mudflows of small volumes are visible. The dirt road on the left side of the Bolshaya Laba River from the village of Damkhurts to the village of Rozhkao suffered more from the rains. Mudflows of 50,000 m³ were observed in the Damkhurts River basin (a wooden bridge was destroyed). Below the Karapyr cordon in the area of the stream, the left tributary of the Bolshaya Laba River, there is a drift and erosion of the road. On the entire left side, as a result of surface washout, the roadbed was damaged (2 landslide massifs). Fresh mudflow deposits are visible in the Zakan river basin. The bridge across the Zakan River is in disrepair. At the intersections of the road with streams (observation points 1110, 1114, 1127), the canvas is completely washed out (traces of backfilling are visible). Above the village of Rozhkao, opposite the bridge, there is a mudflow cone with fresh mudflow deposits at the mouth of the right tributary of the Bolshaya Laba River. The bridge is in disrepair (washed out river banks). The basin of the Rozhkao River, the left tributary of the Bolshaya Laba River, is also mud-bearing: traces of microflows (washout and bank collapse). Below the village of Rozhkao, a mudflow fan is observed at the mouth of the right tributary of the Bolshaya Laba River. The riverbed is divided into 3 branches

(under the road bed there are mudflow trays clogged with fresh mudflow deposits, the possible volume is more than 50,000 m³). As a result of the mudflow along the right slope (observation point 1161), a mudflow was formed. Throughout the entire length of the road on the starboard side (observation points 1162–1172) traces of floods are observed (the road is partially at the level of the river, it was flooded in places). Clearing traces are visible, the floodplain forest is flooded. As a result, a number of landslide massifs formed along the right slope.

The left side of the Bolshaya Laba river. Below (observation points 1173–1179), the road crosses the mudflow fan at the mouth of the right tributary of the Bolshaya Laba River and goes to the left side. In the Asian village (above the village, in the village itself and below the village), there were thin mudflows along the right tributaries. In the area of the village of Kurdzhinovo, the right-bank part (observation point 1195), due to the low level of the road, a section 50 m long was flooded. In the area of the village of Psemen (the Psemenka River, the right tributary of the Bolshaya Laba River), traces of the flood are visible (erosion of the banks and undermining of the bridge supports). In the left-bank part of the village of Kurdzhinovo in the basin of the Beskes River, the left tributary of the Bolshaya Laba River, there are fresh mudflow deposits in the estuarine part (a landslide zone was formed along the left slope, within which residential buildings and part of the road turned out to be).

Urup river basin. In the area of the Trout farm, along the right tributary of the Urup River, erosion of the banks and flooding of the floodplain forest are recorded. Below the Sebeldinka River, the right tributary of the Urup River, on the old alluvial cone at the mouth of the river, fresh mudflow deposits are visible (the dirt road is covered and washed out). The bridge across the Urup River is in disrepair (bank erosion and undermining of the bridge supports). On the left side of the Urup River, in the zone of action of hazardous natural processes, in addition to the road, there is the building of the Urup plant (mine) and a mining village. In the basin of the Vlasenchikha River, the left tributary of the Urup River, (adits and treatment facilities with an industrial site), as a result of mining activities, an anthropogenic zone (a number of tenogenic landscapes) was formed with the development of subsidence processes. On all left tributaries, traces of floods are observed (bank erosion, motorway skidding). The bridge over the Urup River (observation point 1226) is in disrepair. Fresh mudflow deposits are noted in the riverbed. Fresh mudflow deposits are observed on the Urup River and its right tributary, the Seroshtanka River. There is an activation of coastal erosion (bank erosion). Floodplain forests are flooded due to rising water levels in the river. On the left side of the Urup River, below the village of Mednogorsky, an anthropogenic zone has been formed, namely: a tailing dump is located, which is at the stage of reclamation.

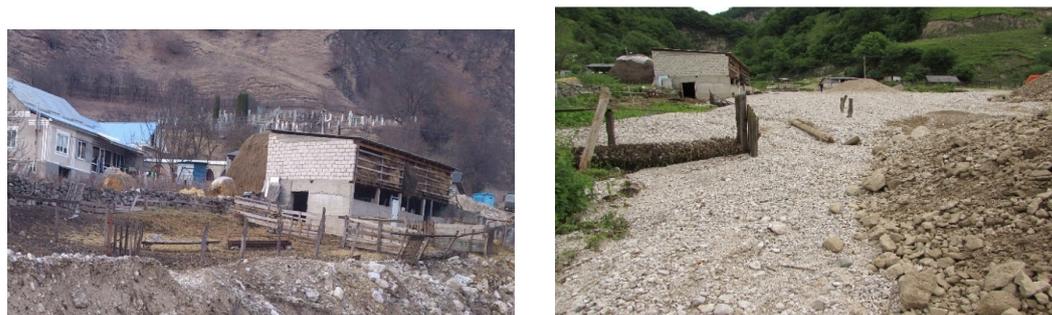
(a) (b)
Figure 4. The left tributary of the Karasu River without a name near the village of Karasu (photo on the left – March 2016), (photo on the right – after the mudflow descent on 06/24/2016). Photo Gedueva M. M.

In the Cherek Bezengisky gorge in the spring of 2016, during field surveys, mudflows of small and medium volumes were recorded, first of all, the left tributary of the Karasu River near the village of the same name (Figure 4).

Surveys with instrumental measurements show that the mudflow was formed as a result of showers the day before, due to the sliding of the slope along the right bank downstream 1000 m above the village of Karasu. The volume of deposited material is 120,000–150,000 m³. Mudflows covered household plots, partially destroyed outbuildings. After the mudflow descent, it was planned to build a mudflow flume along this channel.

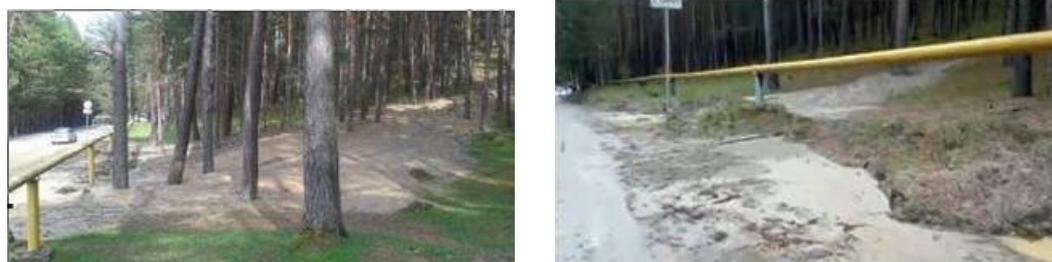
(a) (b)
Figure 5. Sediments after microflow flows along a temporary watercourse of storm origin above the gas station in the Tegenekli settlement. Photo by Kyul E. V. 2017

Also, several sections of the Baksan-Azau highway are periodically covered and washed out by mudflows. Micro-mudflows descend along temporary streams and almost every year and enter the Baksan-Azau federal highway (for example, [Figure 5](#)).

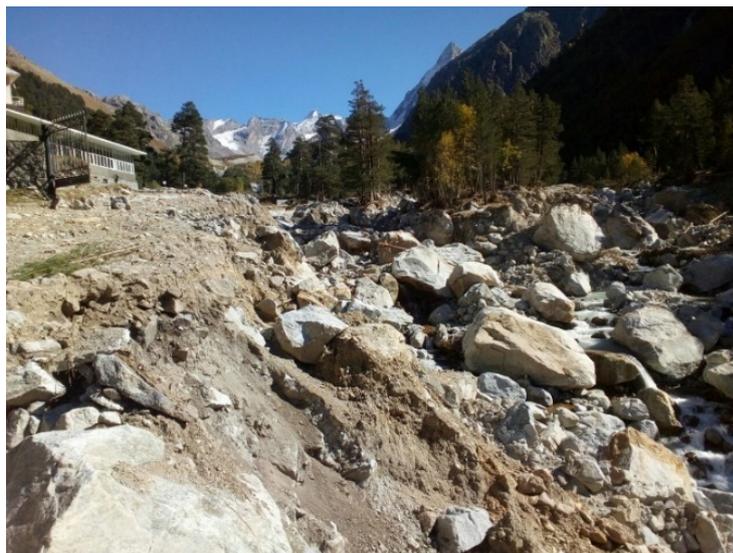
Figure 6. Consequences of the breakthrough of the lake and the descent of the mudflow in the gorge of the river Adylsu. Photo by Dzhappuev D. R.

On September 1, 2017, a catastrophic mudflow formed along the Adylsu and Baksan rivers as a result of the outburst of Lake Bashkara. The breakthrough was caused by anomalous heavy rains that took place the day before and on the night of August 31 to September 1 in the gorge of the Adylsu River, which eroded the ice-moraine bridge. Up to 1 million m³ of water was discharged from the lake. The drop in the water level in the lake is 22–25 meters. According to the automatic weather station installed at the Dzhankuat Moscow State University, from August 28 to September 1, 200 mm of precipitation fell, of which more than 100 mm fell after 20:00 on August 31 (the monthly norm in August is about 80 mm). This mudflow can be attributed to a mixed or glacial-storm type.

As a result, 3 sections of the road were destroyed in the Adylsu gorge and on the very territory of the Dzhantugan base, where eight residential premises were demolished - the so-called “barrels” (for example, [Figure 6](#)). The mudflow washed away seven sections of the A-158 Prokhladny-Azau road, with a total length of 3.3 km. Four bridges across the Baksan River were destroyed, supports were washed away and gabions of the bridge were cut above the village of Neutrino and near the village of Verkhniy Baksan. Three people died.
